## Remove and Replace Bulletin

Symptom: Outside air temperature display functions, but the temperature value is displayed incorrectly. (Value displayed is 5 degrees greater or less than value provided by an independently known source).

Models affected: Paccar vehicles with aero mirrors and an outside air temperature display within the cab or on the exterior mirror glass.

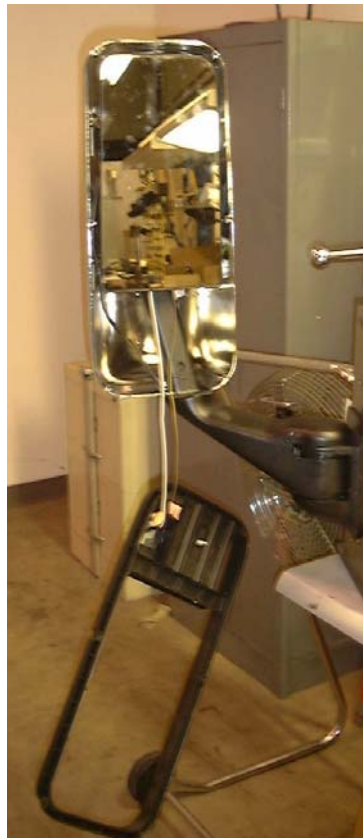
*Image 1 (left) – Bezel removed and hanging from heater wires*

1. Remove the mirror bezel by removing the 6 screws around the perimeter. Allow the bezel assembly to hang from the convex glass heater wires. Be careful not to cut or pinch these wires. *See Image 1*

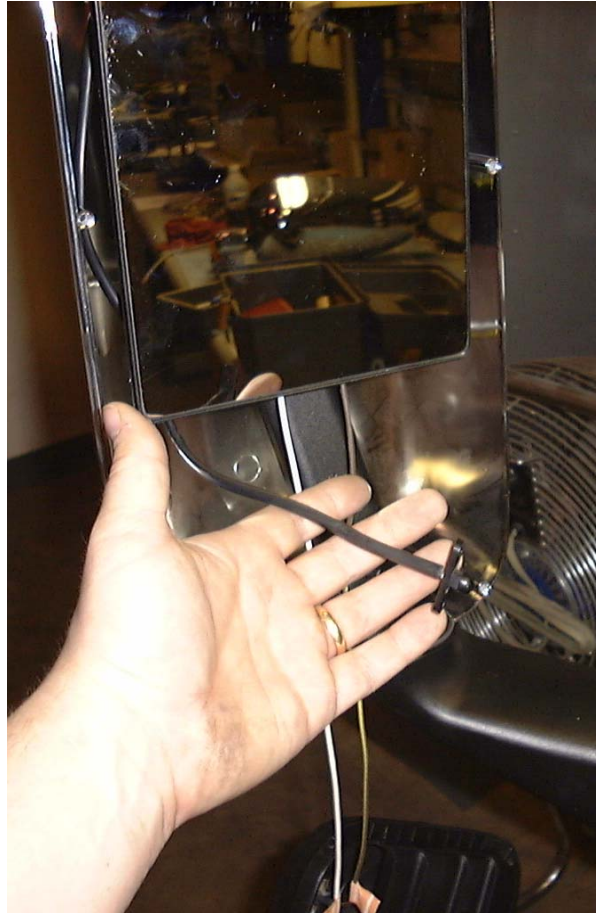
*Image 2 (right) – Sensor exposed after removal of bezel*

2. Slide the sensor out of the slot in the mirror shell. *See Image 2*
3. Cut the sensor wires approximately 4 inches from the base of the sensor.
4. On the portion of the harness remaining in the mirror head, carefully strip back the jacket exposing the two wires. Remove approximately 3" of jacket. *See Image 3*

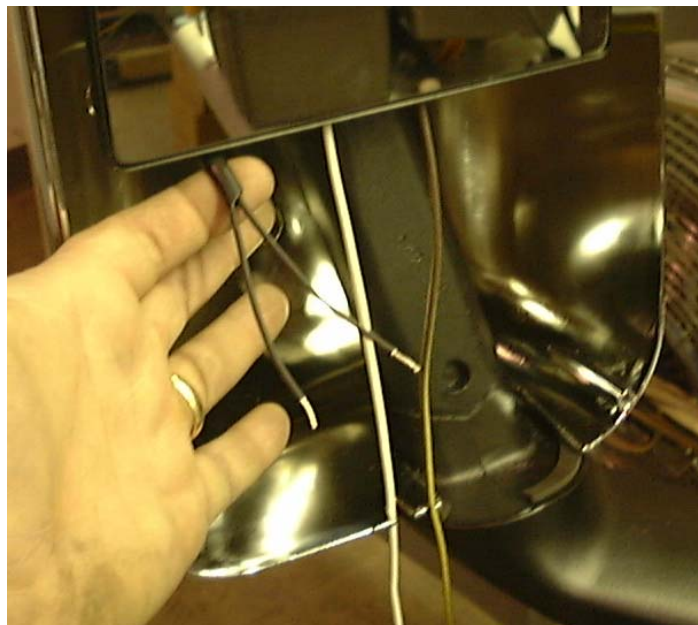
*Image 3 - View of sensor harness after removal of defective sensor*

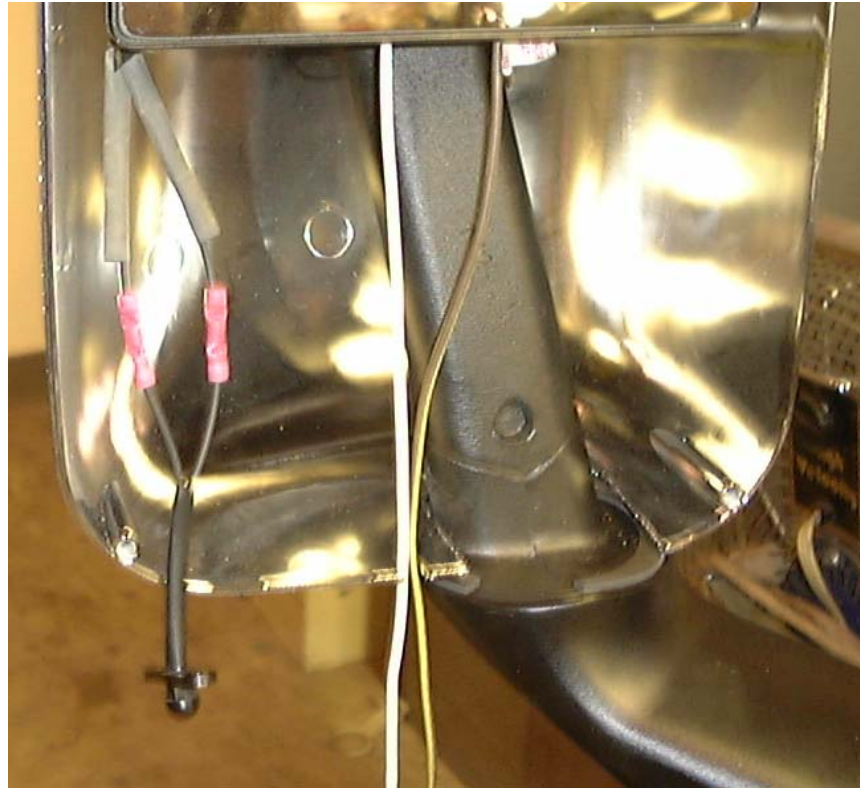
*Image 4 – New sensor connected to existing sensor harness with the use of butt splices*

6. Remove approximately 1/2" of insulation from each of the four wires exposed in steps 4 and 5.
7. Slide the pieces of heat shrink tubing onto the wires, and connect the wire leads by using 2 butt splice connectors. Note: Sensor is not polarity sensitive. *See Image 4*

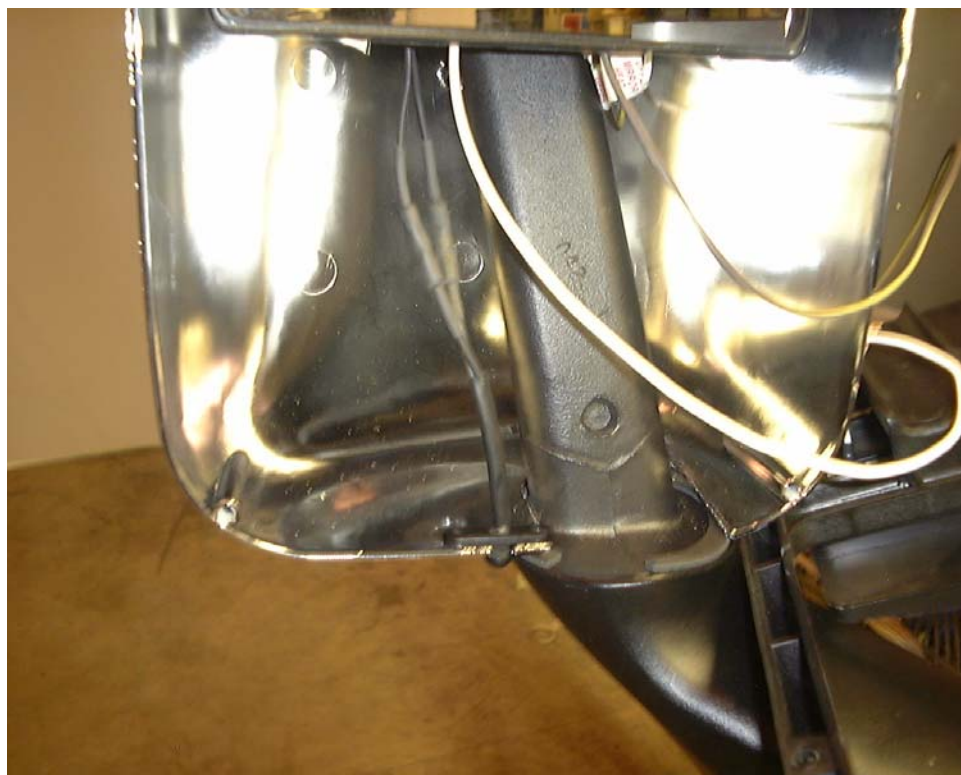
*Image 5 – Splice connections covered with heat shrink tubing, and new sensor placed into slot on mirror shell*

8. Cover the connections with heat shrink tubing. Note: shrink tubing needs
9. Slide the new sensor into the slot on the bottom of the mirror shell. *See Image 5*
